1995 INTERNATIONAL 4900 | 1HTSDAAN45H616739

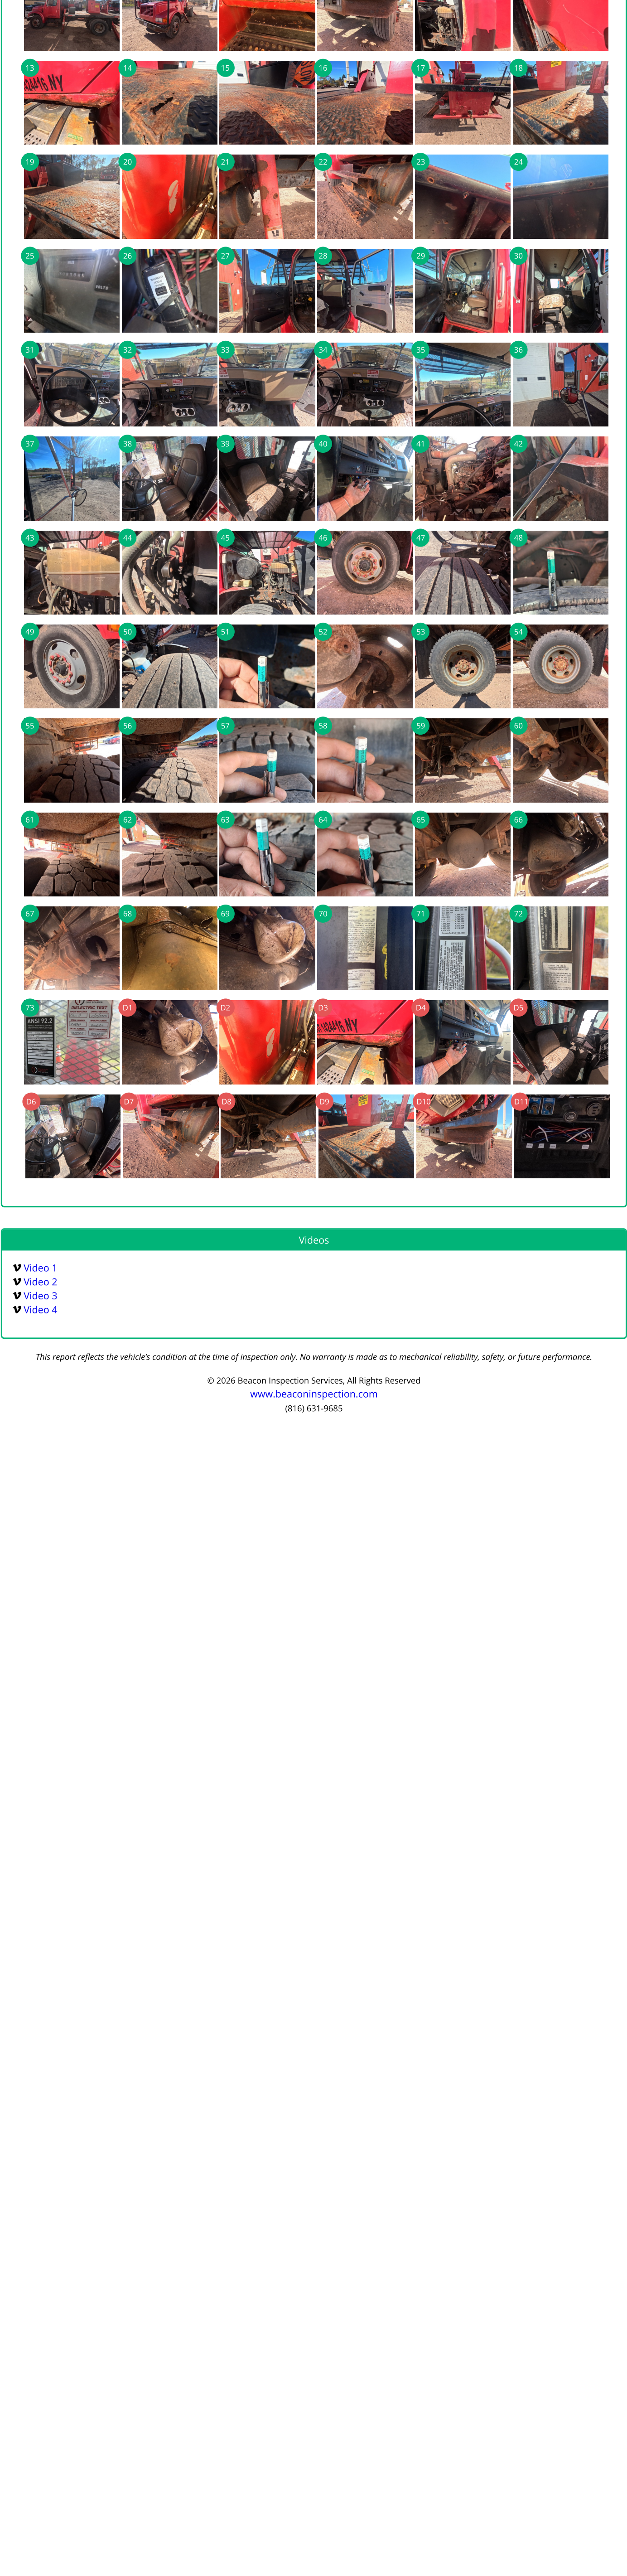
| Deficiencies | | | |
|---|---|---|---|
| D1 | Underbody | Engine Oil Leak | |
| D2 | Exterior | Cracked And Bubbled Paint | |
| D3 | Exterior | Surface Rust On Exterior Components | |
| D4 | Mechanical | Manual Fuel Shutoff Handle Required To Stop Engine | |
| D5 | Interior | Passenger Seat Extremely Worn | |
| D6 | Interior | Drivers Seat Cracked/Worn | |
| D7 | Exterior | Driver/Passenger Steps Rusted | |
| D8 | Underbody | Undercarriage Extremely Rusted | |
| D9 | Exterior | Flatbed Severely Corroded/Rusted | |
| D10 | Exterior | Front Bumper Rusted | |
| D11 | Interior | Exposed Wiring In Radio Compartment | |
