2019 FREIGHTLINER M2 | 1FVACXFC4KHK56850

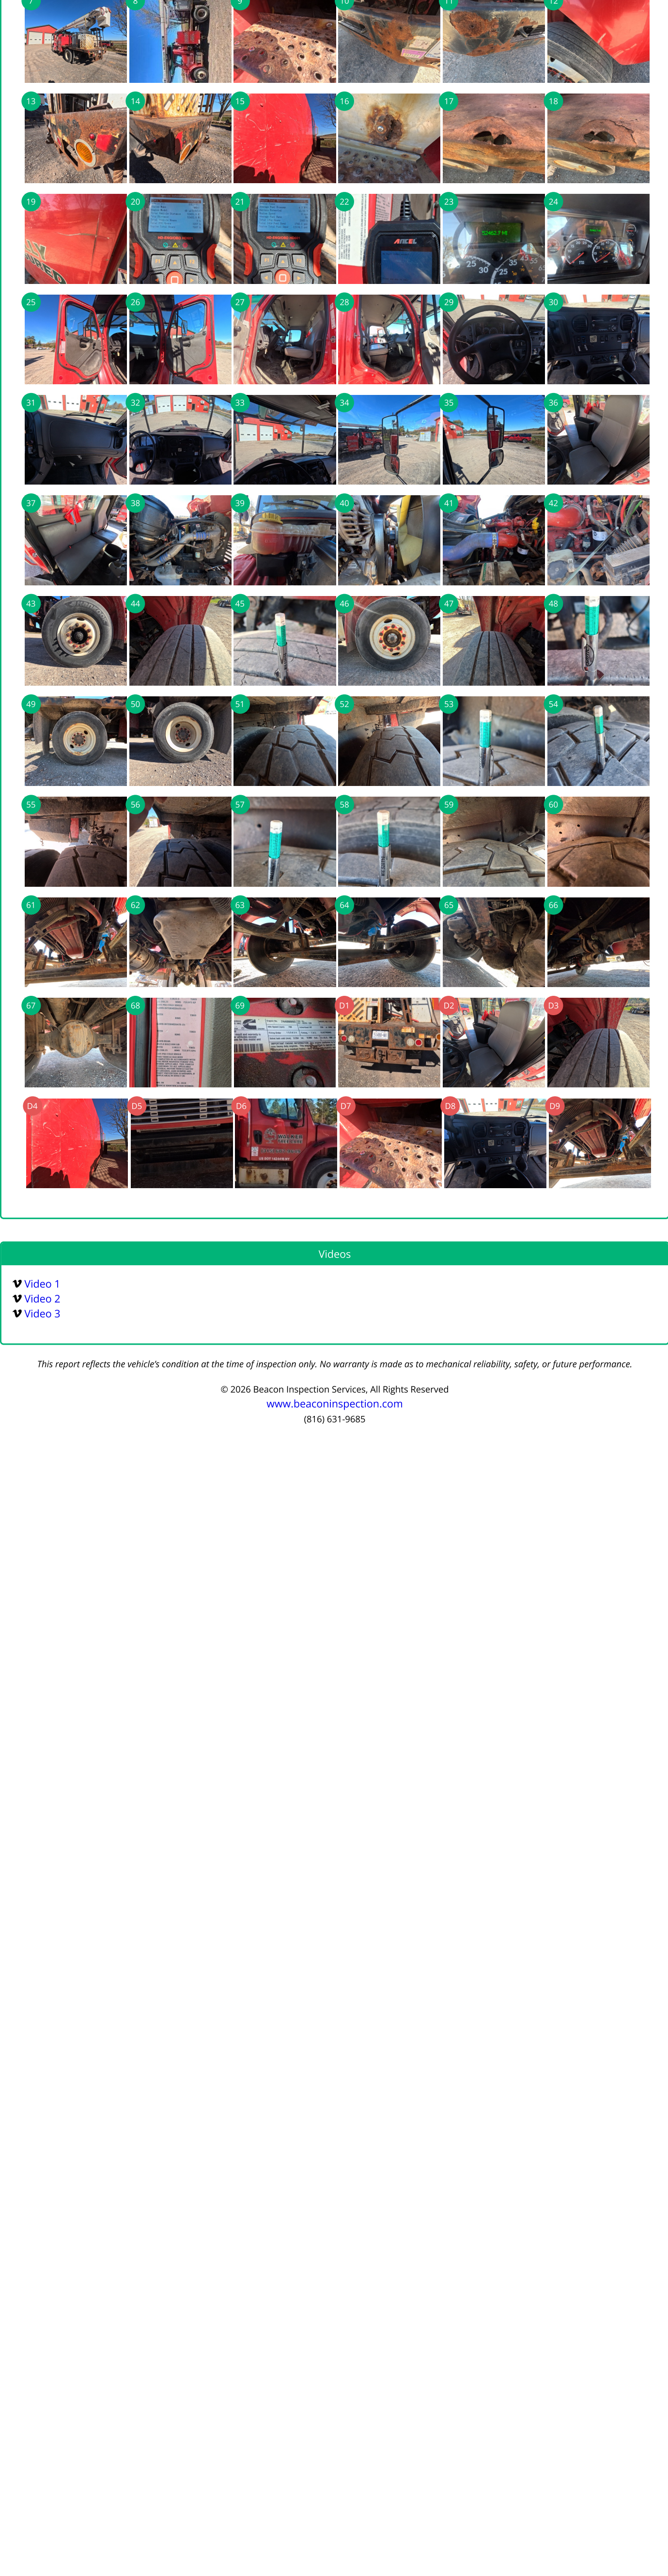
| Deficiencies | | | |
|---|---|---|---|
| D1 | Exterior | Surface Rust on Metal Components | |
| D2 | Interior | Damaged Interior Seats | |
| D3 | Tires | Uneven Tire Wear | |
| D4 | Exterior | Scratched Exterior Paint | |
| D5 | Exterior | Front Bumper Has Severe Rust | |
| D6 | Exterior | Personal Decals On Driver/Passenger Door | |
| D7 | Exterior | Driver/Passenger Steps Rusted | |
| D8 | Interior | Aftermarket Cables | |
| D9 | Underbody | Severe Rust On Undercarriage | |
