2021 FREIGHTLINER M2 | 1FVACWFC4MHMN6711

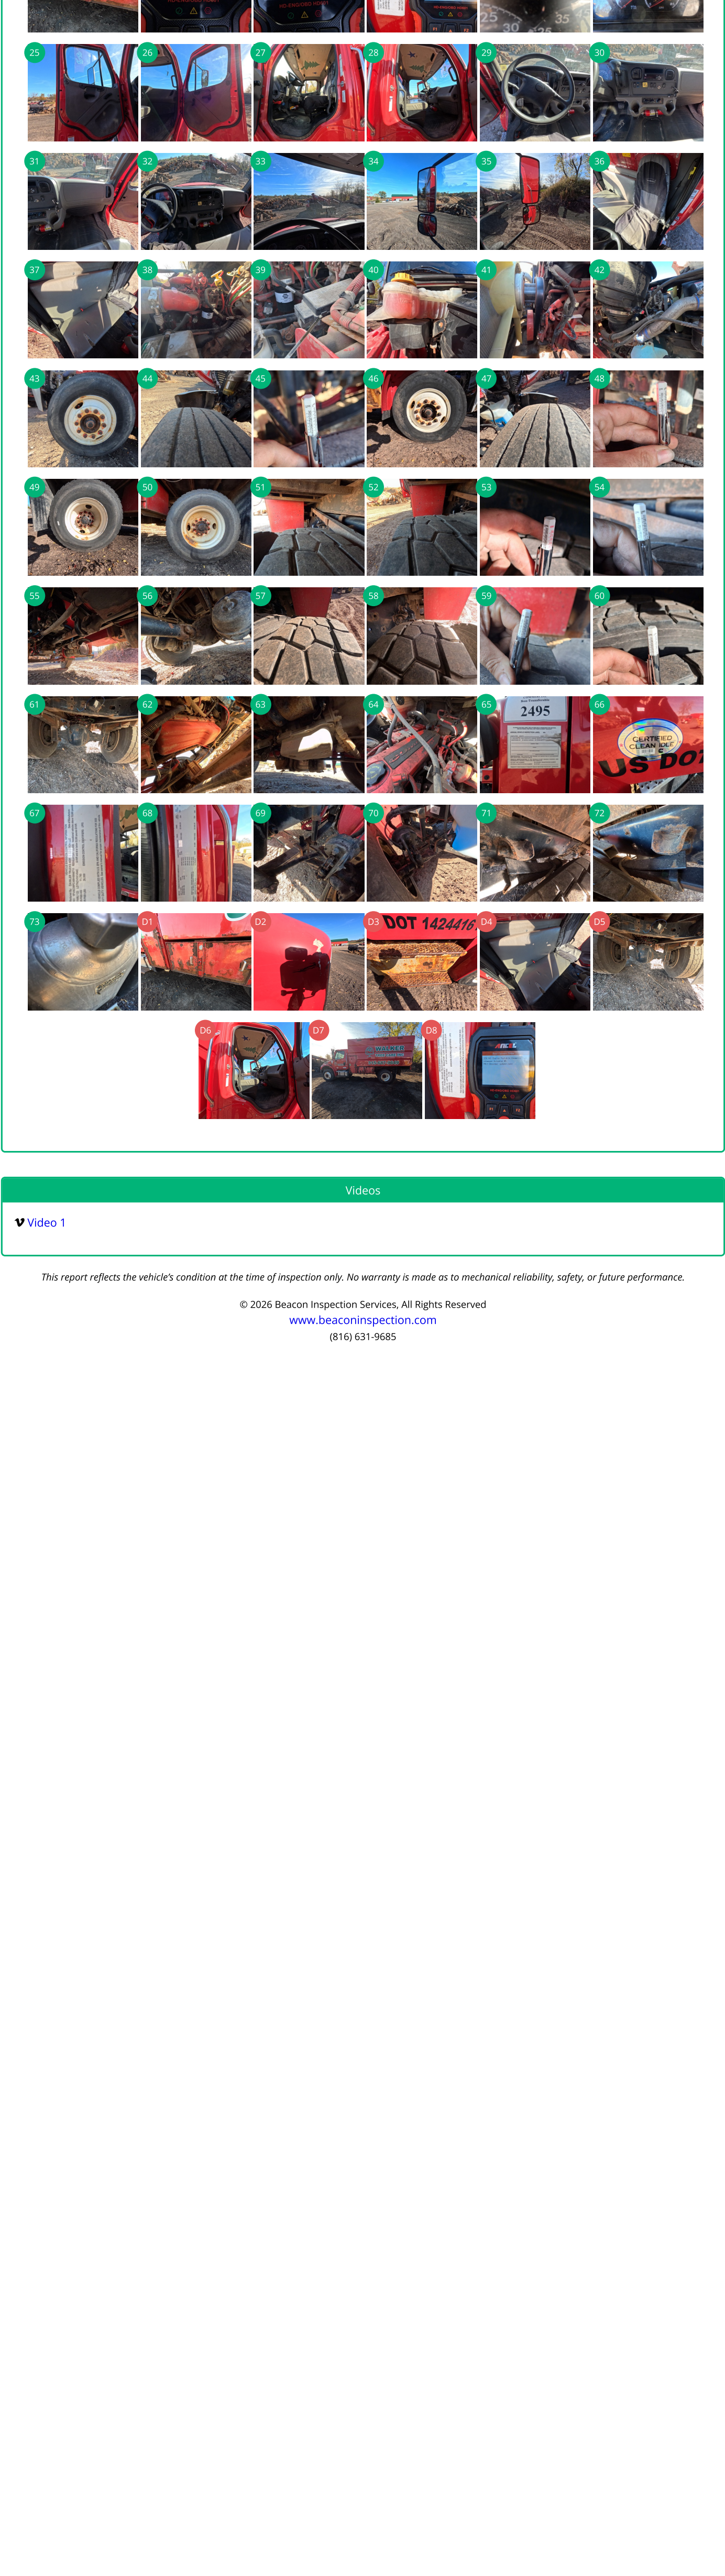
| Deficiencies | | | |
|---|---|---|---|
| D1 | Exterior | Surface Corrosion Present on Metal Components | |
| D2 | Exterior | Paint Cracking/Scraped | |
| D3 | Exterior | Driver/Passenger Steps Rusted And Corroding | |
| D4 | Interior | Interior Seat Upholstery Damaged | |
| D5 | Underbody | Severe Rust On Undercarriage | |
| D6 | Interior | Personal Decor On Headliner | |
| D7 | Exterior | Personal Decals On Driver/Passenger Side | |
| D8 | Fault Code | SPN 641 FMI 9 Variable Geometry Turbocharger (VGT) Actuator Fault | |
