2007 FORD F-750 | 3FRXF75627V515423

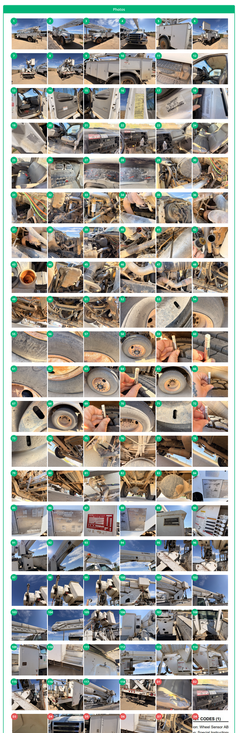
Issue #	Check	Comment	Photo
1	Interior	Drivers seat torn	
2	Interior	Dash is cracked and broken with missing blank covers	
3	Interior	Headliner is stained	
4	Exterior	Grille is loose with zip tie repair	
5	Utility box	Drivers side panels scratched and dented	
6	Exterior	Utility step bar damaged	
7	Engine	Pan is moist with oil residue but no obvious leak identified	
8	Fault code	SID 3 FMI 14 Wheel sensor ABS
